**Panama Maritime Authority**  
Directorate General of Merchant Marine  
Maritime Affairs Investigation Department

**M/V “EVER GIVEN”**  
**IMO No. 9811000**  
**R-026-2021-DIAM**  
**CASUALTY DATE: March 23<sup>rd</sup>, 2021**

**MARINE SAFETY**  
**INVESTIGATION REPORT**  
**GROUNDING**  
**OF**  
**MV EVER GIVEN**  
**AT**  
**SUEZ CANAL EGYPT**  
**ON**  
**MARCH 23, 2021**

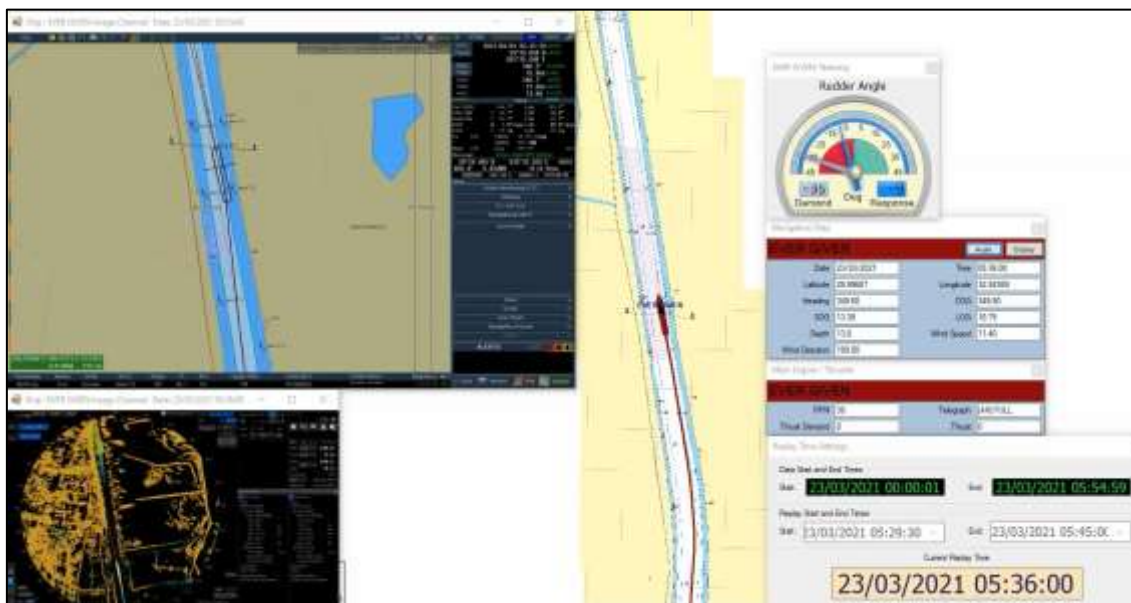
**FIGURE 7: VESSEL POSITION AT 07:36 HRS / LT**  
(Source: Extracted from vessel VDR)

At about **07:36 HRS / LT**, the vessel was positioned on the starboard side of the canal. At about **07:37 HRS / LT** pilot ordered correcting rudder and started to turn back to port, again using large helm order, not course orders.

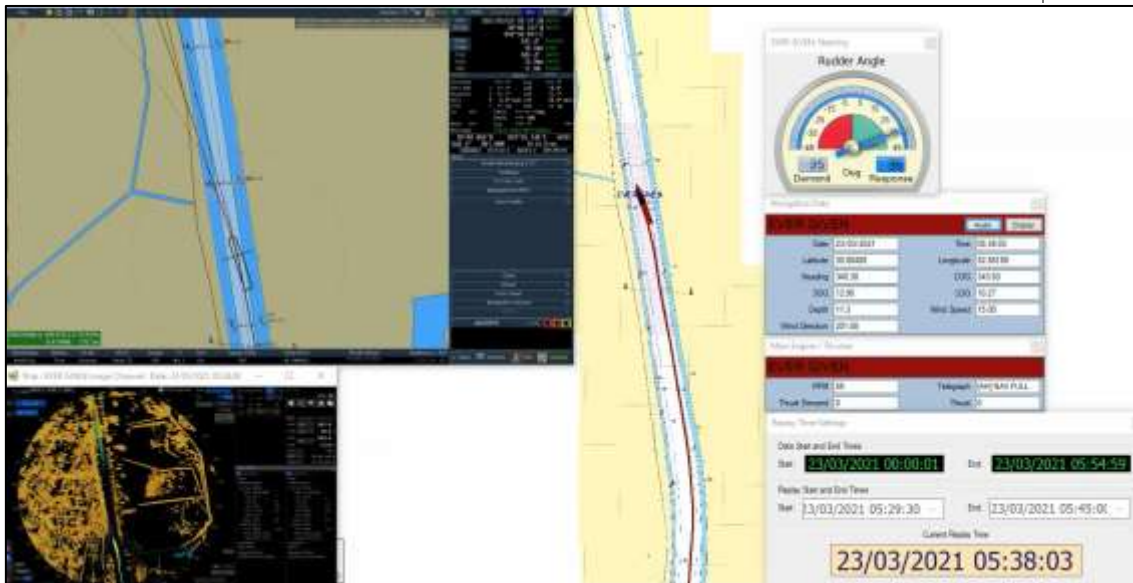
**FIGURE 8: VESSEL POSITION AT 07:38 HRS / LT**  
(Source: Extracted from vessel VDR)

At about **07:38 HRS / LT**, the helmsman reported that the vessel had stopped turning to port and was starting to turn to starboard. At the time, the vessel was close to the port bank of the canal and the speed had increased to about 13 knots over the ground. The vessel then started to turn quickly to starboard, away from the port bank. The pilot initially ordered the rudder to port 20 degrees and then hard to port to stop the vessel from turning. Then the second pilot started shouting at the first pilot in local language, there appeared to be a disagreement between them.

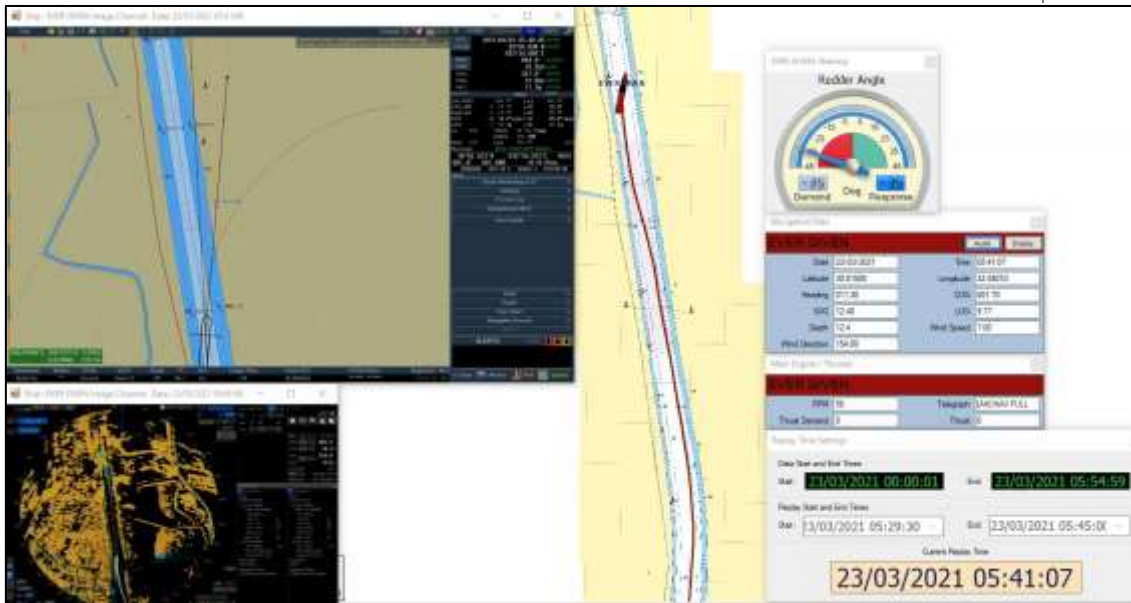
**FIGURE 9: VESSEL POSITION AT 07:41 HRS / LT – GROUNDING**  
(Source: Extracted from vessel VDR)

The first pilot reduced speed to half ahead at **07:39:55 HRS / LT** and the vessel continued to turn to starboard. There was another discussion between the two pilots in local language and the main engine was increased to full ahead again. The vessel continued to turn starboard, towards the starboard canal bank. The pilot again ordered hard to port presumably to try to steady the heading but vessel continued turning to starboard side. The main engine revolutions were increased to Nav full ahead (53 RPM) but still the vessel was swinging heavily starboard. The vessel continued this swinging and grounded at a speed of about 12 knots over the ground on the eastern bank of the canal at **07:41 HRS / LT**, at location 30 01.059 N / 032 34.810E. On grounding the pilot at (**07:43 HRS / LT**) ordered Full Astern and then Crash Astern (**07:44 HRS / LT**), neither orders had any effect. Master also ordered the bow thruster to be started after the grounding, in his first effort to refloat vessel.

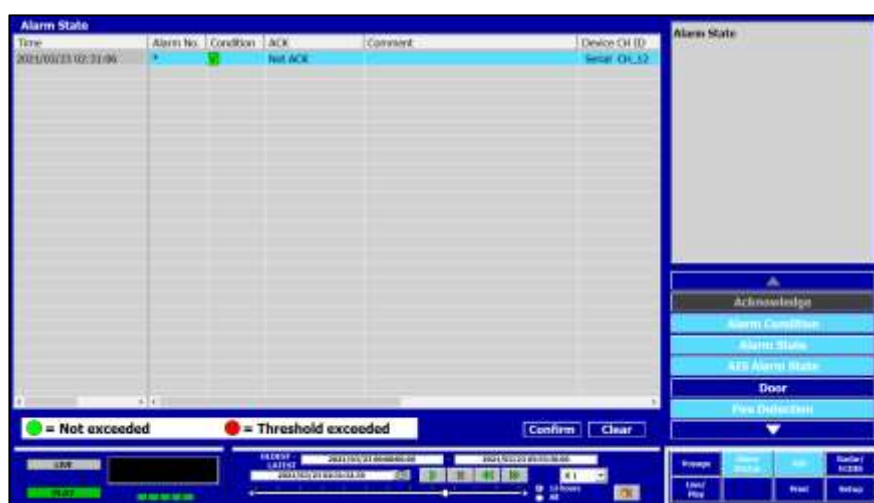
FIGURE 11: Alarm Status - (Source: Extracted from VDR data / Alarm Status)

Vessel’s bridge alarm status reviewed and found that during the period of analysing the VDR Data there were no any error alarms.

**Note:** Bilge alarm was noted at 07:45:54 HR LT, 4 minutes after the grounding, due to the water ingress in the bilge flowing aft (change in trim).

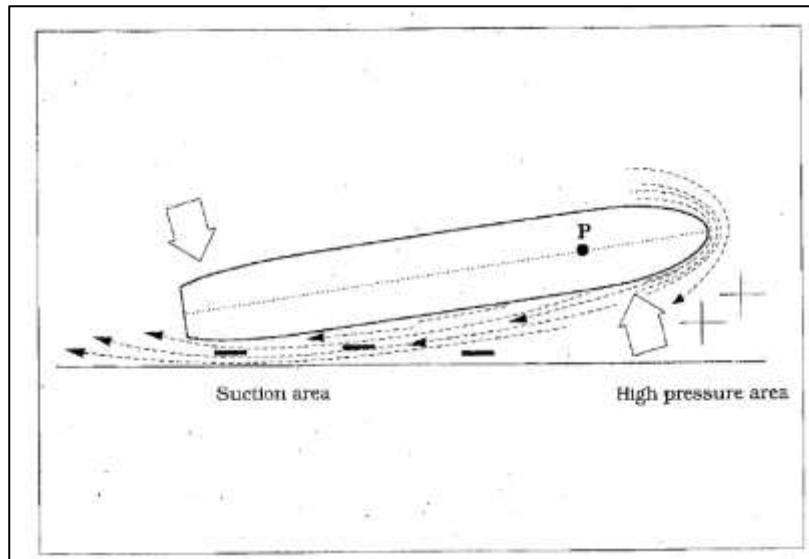
**FIGURE 13: BANK EFFECT**  
(Source: Nautical Institute's "Shiphandler's Guide")

If a vessel moves away from the center-line of a canal towards one of the banks, the flow of water between her side and the nearer bank becomes confined, and therefore lower pressure (greater suction) will occur on that side. This suction will tend to pull the vessel towards the nearer bank. However, it should be noted that these suction forces are not evenly distributed along the length of the hull and their resultant tends to act somewhere aft of amidships. This is equivalent to a force acting aft of the center of gravity which creates a turning moment, deflecting the ship's head away from the nearer bank. In practice this turning moment overrides the bodily suction towards the nearer bank and the vessel will start moving away from it, sometimes so violently that a sheer towards the opposite bank is generated."

According to the crew statements, master's statement of facts and as illustrated in ECDIS play back and VDR data, M/V **EVER GIVEN**, at about **07:38 HRS / LT**, the helmsman reported that the vessel had stopped turning to port and was starting to turn to starboard. At the time, the vessel was close to the port bank of the canal and the speed had increased to about 13 knots over the ground. The vessel then started to turn quickly to starboard, away from the port bank, that was the time that a combination of squat and bank effect started to heavily effect vessel, due to high speed.

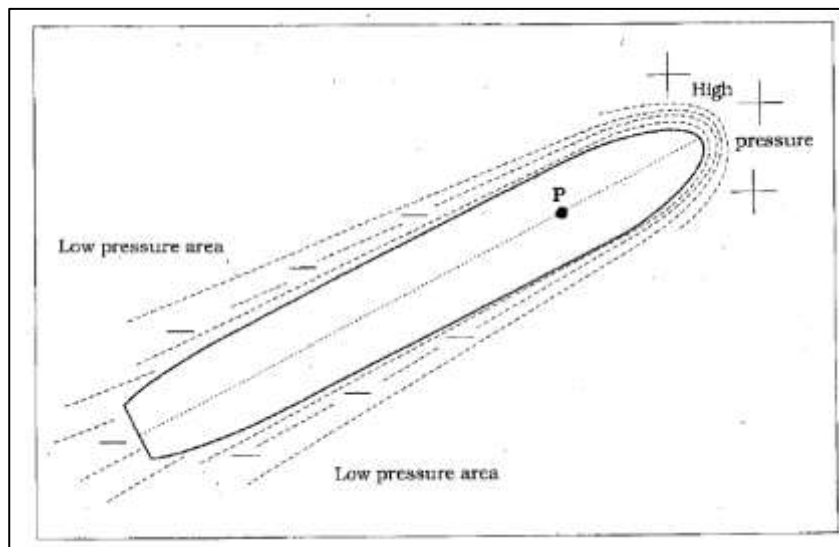
**FIGURE 14: PRESSURE ZONES**  
(Source: Nautical Institute's "Shiphandler's Guide")

Following diagrams from the Nautical Institute's "Shiphandler's Guide" shows that both squat and bank effect has a detrimental effect on steering.
