**Panama Maritime Authority**  
Directorate General of Merchant Marine  
Maritime Affairs Investigation Department

**M/V “EVER GIVEN”**  
**IMO No. 9811000**  
**R-026-2021-DIAM**  
**CASUALTY DATE: March 23<sup>rd</sup>, 2021**

**MARINE SAFETY**  
**INVESTIGATION REPORT**  
**GROUNDING**  
**OF**  
**MV EVER GIVEN**  
**AT**  
**SUEZ CANAL EGYPT**  
**ON**  
**MARCH 23, 2021**

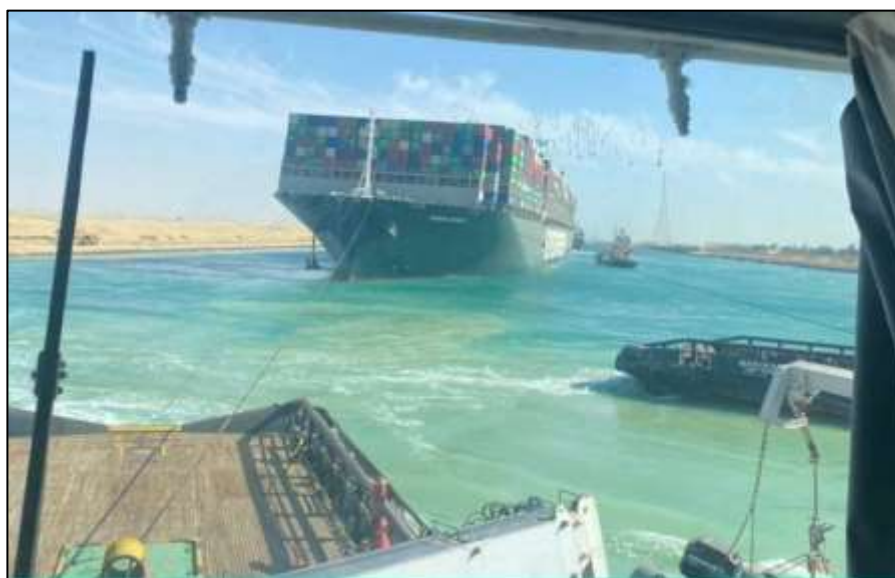
**FIGURE 10: M/V EVER GIVEN PULLED FREE**

On **29 March 2021**, the stern of M/V EVER GIVEN was refloated at **04:30 HRS / LT** and on **15:05 HRS / LT** local time the ship was pulled free, and was towed to the Great Bitter Lake for inspection.

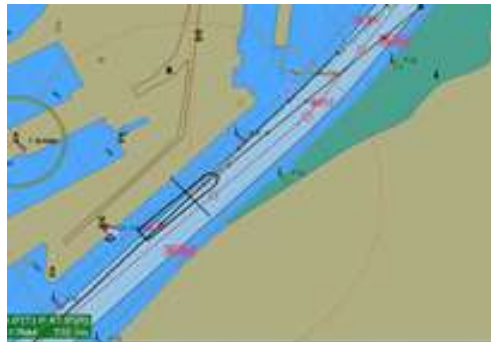
**Important Event**

The loss of steering control likely started in this moment due to the Bank Effect  
 The South wind pushing the vessel towards the portside bank of the canal.

<b>Key Issues</b>	No any alarm
<b>Relat. Wind Direction/Speed</b>	084°/7.0 m/s
<b>Speed (STW)</b>	6.6 kts
<b>Depth</b>	12 m
<b>Heading</b>	047°8

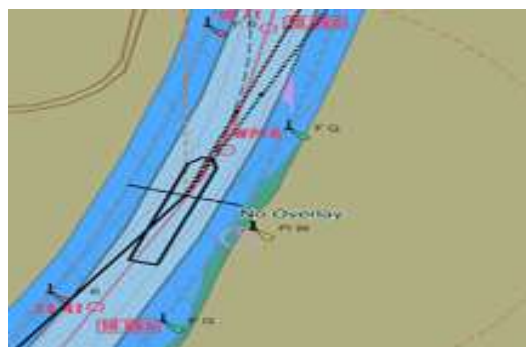
**Important Event**

The **swinging** between starboard side and portside banks of the canal already started.

<b>Key Issues</b>	No any alarm Extreme Steering angles
<b>Relat. Wind Direction/Speed</b>	<b>155°/12.1 m/s</b>
<b>Speed (STW)</b>	<b>10.4 kts</b>
<b>Depth</b>	<b>11.5 m</b>
<b>Heading</b>	<b>015.1°</b>

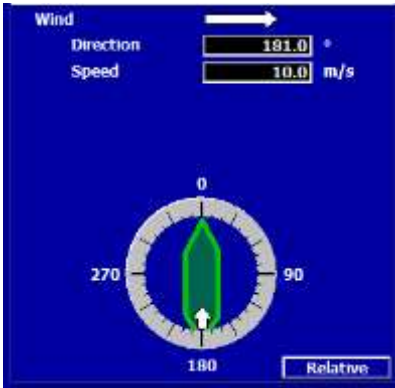
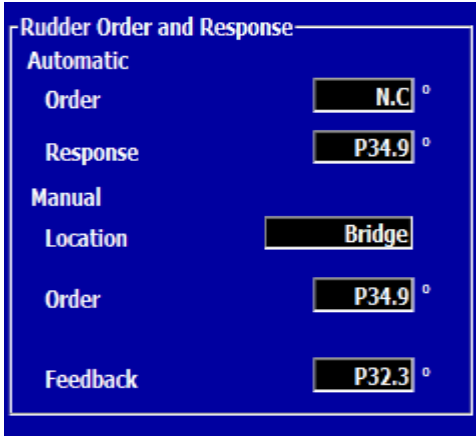
Date/Time: 23.03.2021/05:40 UTC  
 Event: Transiting Suez Canal

Analysis from: 05:37 hrs UTC, to 05:40 hrs UTC Navigation: <ul style="list-style-type: none"> <li>Recording started at 00:00:00 UTC</li> <li>All data available from 00:00:00 UTC onwards.</li> <li>At 0511 hrs (UTC) entering Suez Canal</li> </ul>	
<b>Key Issues</b>	No any alarm
<b>Important Event</b>	None
<b>Relat. Wind Direction/Speed</b>	<b>181°/10. m/s</b>
<b>Speed (STW)</b>	<b>10.6 kts</b>
<b>Depth</b>	<b>12.5 m</b>
<b>Heading</b>	<b>357.8°</b>

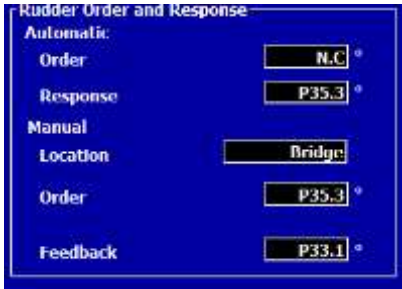
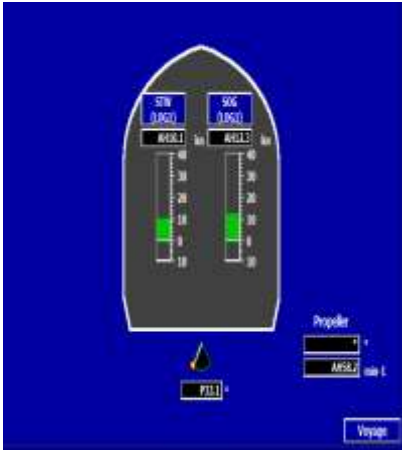
Date/Time: 23.03.2021/05:41 UTC  
 Event: Grounding

<b>Key Issues</b>	No any alarm Extreme Steering angles
<b>Relat. Wind Direction/Speed</b>	<b>152°/10.8 m/s</b>
<b>Speed (STW)</b>	<b>10.1 kts</b>
<b>Depth</b>	<b>2.5 m</b>
<b>Heading</b>	<b>016.3°</b>

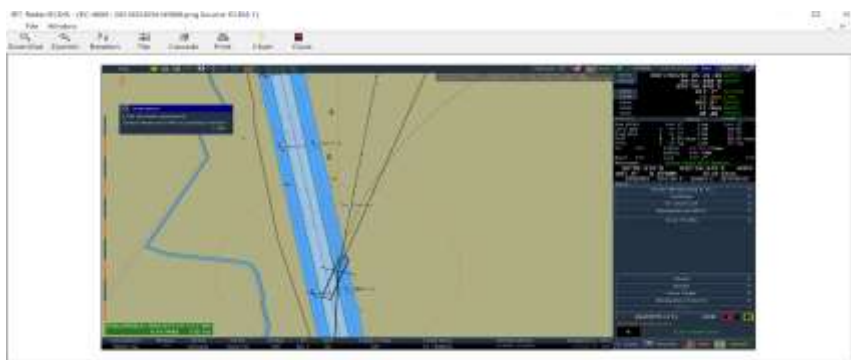
**ECDIS 1**

After the last swinging movement vessel runs **aground**
